UNDERWATER BRIDGE INSPECTION REPORT

STRUCTURE NO. 02526
CSAH NO. 7
OVER THE
RUM RIVER
DISTRICT 5 - ANOKA COUNTY

PREPARED FOR THE
MINNESOTA DEPARTMENT OF TRANSPORTATION
BY
COLLINS ENGINEERS, INC.
JOB NO. 3512 (CEI 105)

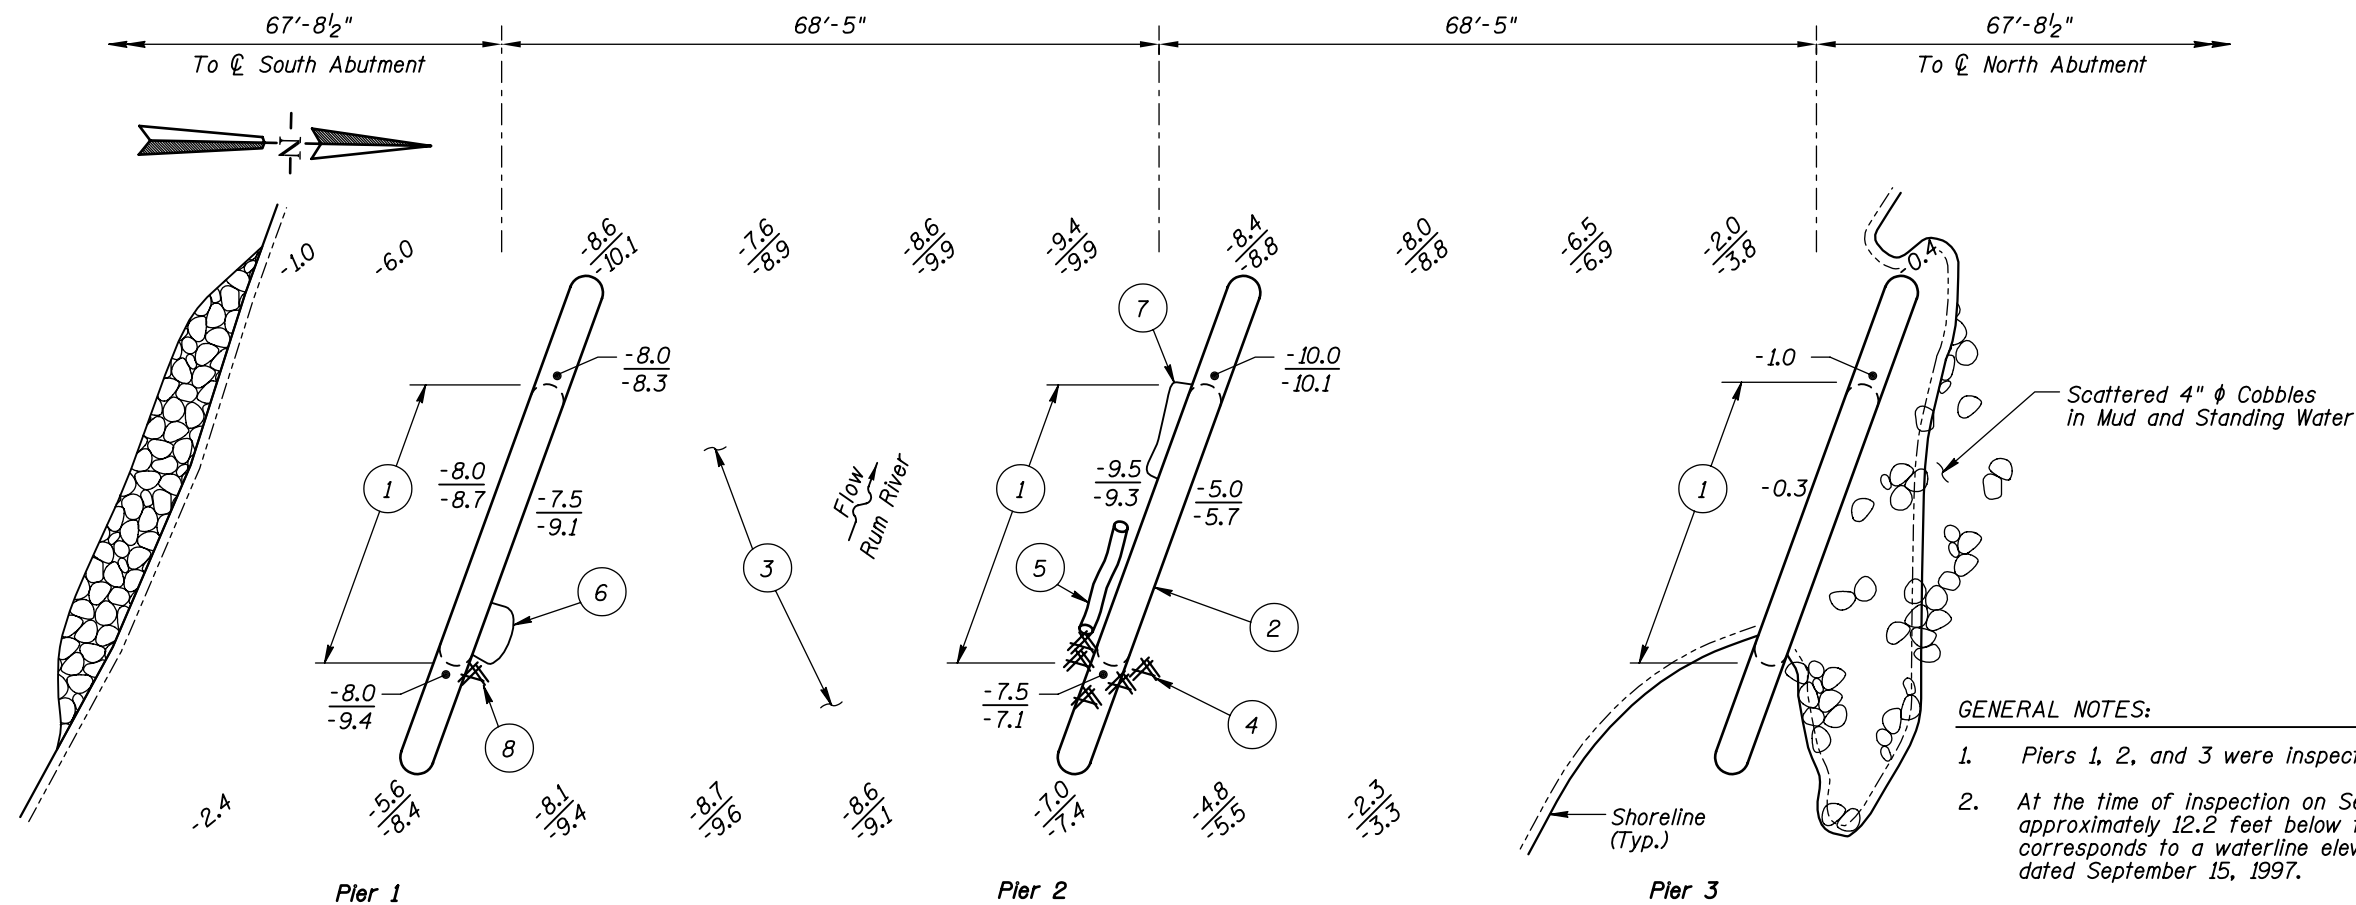
SOUNDING PLAN

- 1 Overall, the concrete piers were in good, sound condition with no defects of structural significance.
- 2 Light scaling was observed from the waterline to 3 feet below the waterline with a maximum penetration of 1/8 inch.

- 3 The channel bottom consisted of firm sand with 2 to 3 inches of probe rod penetration and 12-inch-diameter riprap located at the upstream noses of Piers 1 and 2 and along the south face of Pier 1.

- 4 A moderate accumulation of 6- to 8-inch-diameter timber debris was located at the upstream end of Pier 2.
- 5 A 12-inch-diameter log was observed on the channel bottom along the pier shaft.

- 6 A 3-foot-radius, 1-foot-deep scour pocket exposed the top of footing at Pier 1.
- 7 An 11-foot-long by 3-foot-wide portion of the footing was exposed along Pier 2 with 1 foot of the vertical face exposed.

- 8 An 8-inch-diameter piece of timber debris was observed at the upstream end of Pier 1.

- (A) Monitor footing exposure during future inspections.
- (B) Reinspect the submerged substructure units at the normal maximum recommended (NBIS) interval of five (5) years.

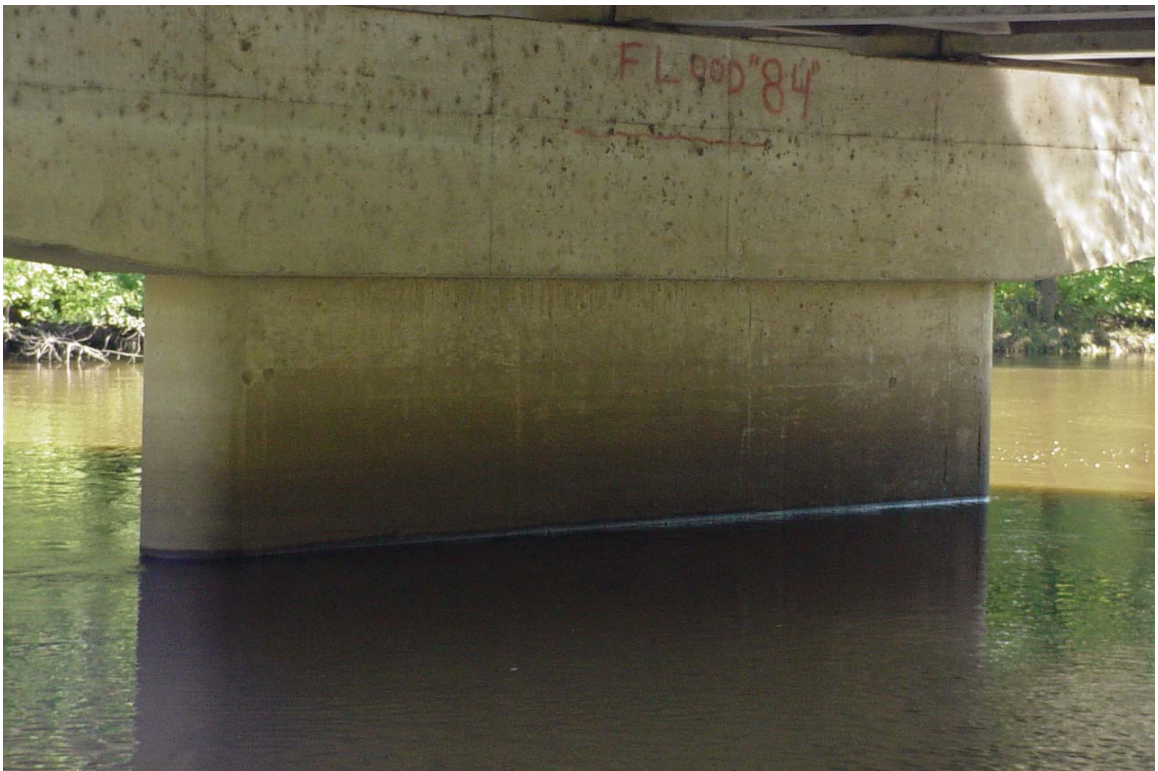
Photograph 2. View of Pier 1, Looking Northeast.

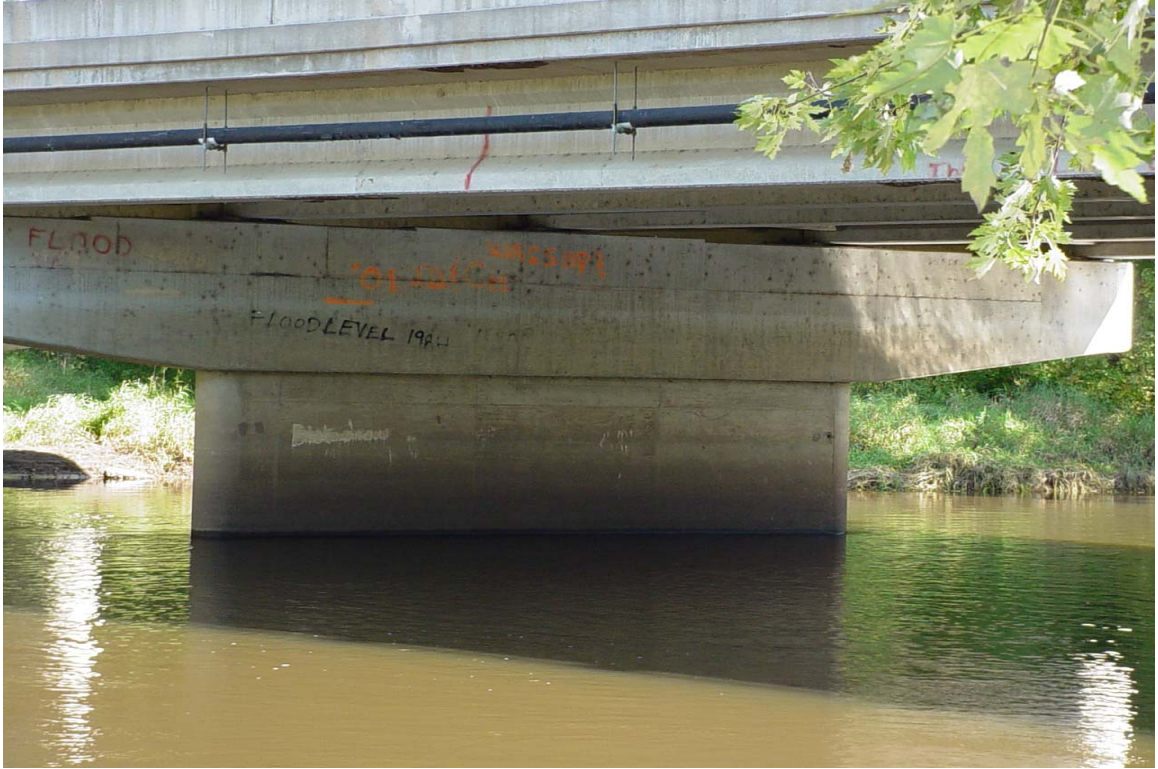
- (A) Overall, the concrete piers were in good and sound condition with no defects of structural significance; however, light scaling was observed at Pier 2 from the waterline to 3 feet below the waterline with a maximum penetration of 1/8 inch.
- (B) A moderate accumulation of 6- to 8-inch-diameter timber debris was located at the upstream end, and a 12-inch-diameter log was observed on the channel bottom along the shaft of Pier 2. An 8-inch-foot-diameter piece of timber debris was also observed at the upstream end of Pier 1.
- (C) A 3-foot-radius, 1-foot-deep scour depression exposed the top of footing at the upstream end of Pier 1. An 11-foot-long by 3-foot-wide portion of the footing was exposed along Pier 2 with 1 foot of the vertical face exposed.

Photograph 3. View of Pier 2, Looking Northeast.

Monitor the footing exposure during future inspections.

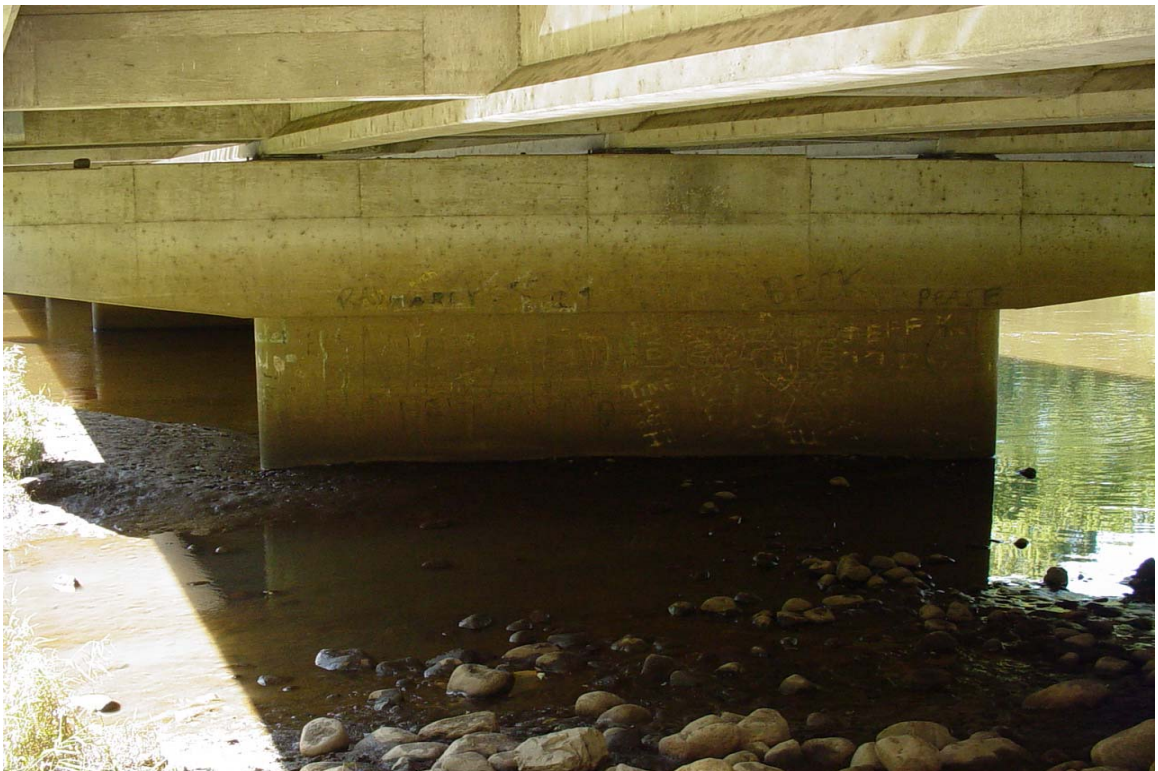
Photograph 4. View of Pier 3, Looking Southwest.
